PROJECT SNAPSHOT

HULCHER FORKLIFT, CREW LOAD-ADJUST ROOFING TILES

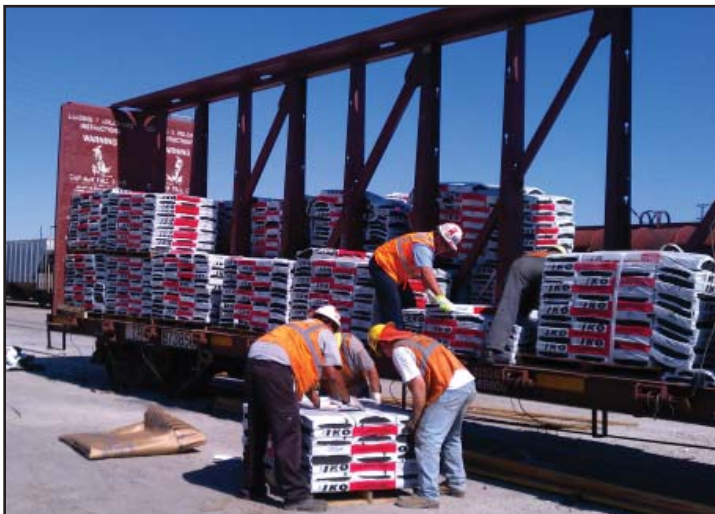
Eighteen pallets of roofing tiles on a center beam railcar shifted during transit, crushing their pallets and damaging the banding. Hulcher sent a crew of five personnel, a forklift, replacement pallets and a banding machine to remedy the problem. The crew unloaded the roofing materials onto the new pallets and the Hulcher forklift placed them back on the car. Once the pallets were properly positioned, the crew used the banding machine to secure the load with 1.5" steel band, cabling and 2" x 6" wood pieces in accordance with AAR standards.
