CASE STUDY

HULCHER REMEDIATES POND AT CHEMICAL MANUFACTURING FACILITY

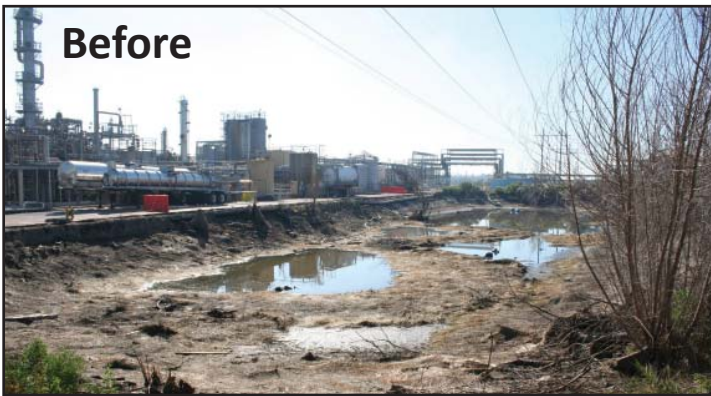
Before

A chemical manufacturing facility was closing a pond on their property, and the pond required remediation before it was filled in. They needed a contractor with the expertise and heavy equipment to clean and restore the site.

Hulcher's crews stabilized the pond bottom using fly ash and cement kiln dust to bind the matrix, placed and regraded the site fill material and brought in sand and clay to fill the pond.

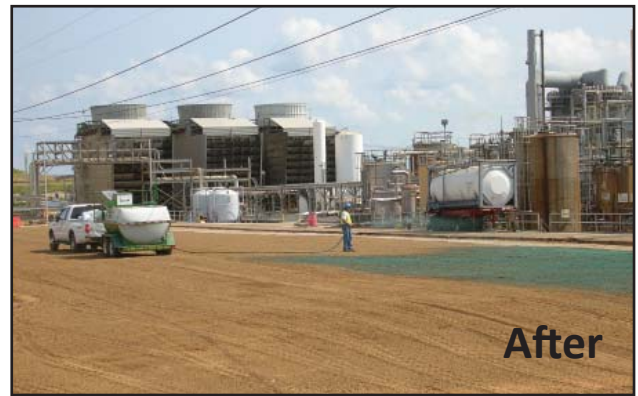
After

Over a two-month period Hulcher transformed a closed pond that was an eyesore into an attractive, open space that added visual appeal to the property. Hulcher's environmental professionals led this project from start to finish, and their expertise resulted in a properly remediated space with all the necessary drainage to keep it functional and aesthetically pleasing for years to come.

Hulcher completed the project by placing topsoil and seeding the area for grass.
